Subject: Revised Root Cause Investigation – Diesel Generator Amphenol Connector
Cooper Nuclear Station, Docket No. 50-298, DPR-46

Root Cause Investigation (Rev. 1)
Unexpected DG-2 Shutdown
CR-CNS-2008-00304
Dated 7/11/2008

ROOT CAUSE INVESTIGATION (REV. 1)

UNEXPECTED DG-2 SHUTDOWN CR-CNS-2008-00304

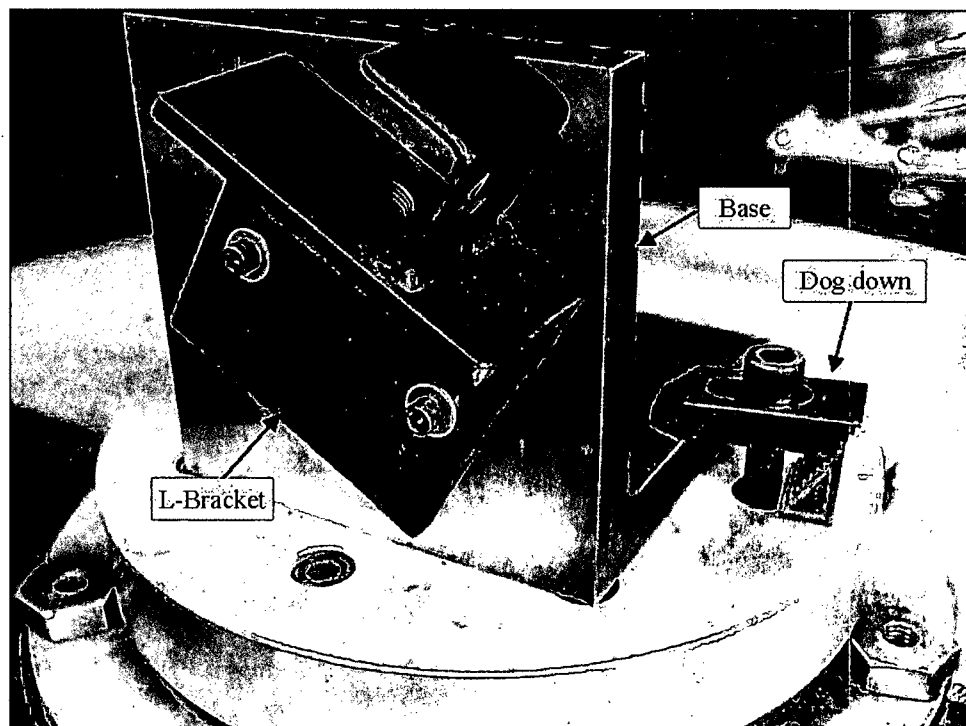
Figure 5. MPU Test Rig for Vibration Testing Set to 30° and Secured to the Shaker Plate

The base of the test rig was constructed from a 0.8 inch thick carbon-steel mounting bracket, 6 inches tall by 6 inches wide. The MPU is held by a smaller L-bracket constructed from ¼ inch steel stock which can be bolted to the larger L-bracket at angles of 0, 30, 60, and 90 degrees. The smaller L-bracket's vertical face is threaded to accommodate the MPU and is locked in position with the MPU's nut. The base is secured to the shaker plate using a "dog down" or setup clamp. Three of these set-up clamps are used to secure the mounting bracket. Figure 5 (below) shows a photograph of the test rig mounted on the shaker plate.

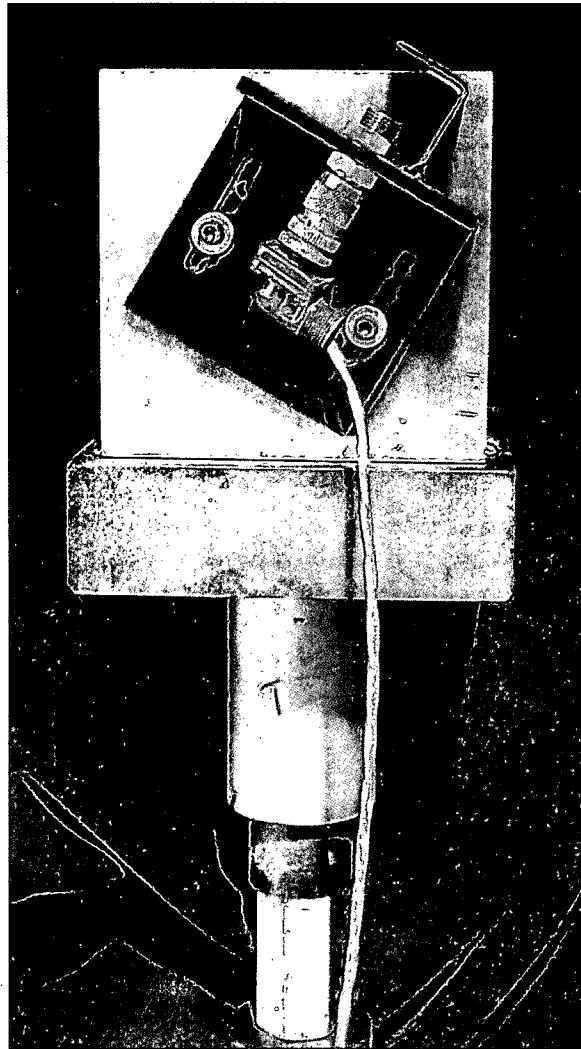
Figure 6. MPU Test Rig in Servo-Hydraulic Frame for Long-Term Vibration

The long-term testing was initiated on June 27, 2008 at 3:42:27 PM and continued for a total of 10 days (240 hours). The following conditions were used for this testing:
